Hyper-pressurization of the dialysate fluid as a temporary solution to the failure of the dialysate flow pump in volumetric hemodiafiltration machines

Technical case: The monitor is an NCU-18-Nipro hemodiafiltration machine with 14426 hours of use. During the startup test, the system reported an error in the flow control of ultrafilter one due to a loss of power from pump 1 of the dialysate flow; the position of the head from pump P2 to pump P1 was changed, and system pressurization calibration. The problem was temporarily resolved for three months. After this period, the error occurred again; it was decided to hyper-pressurize the system, with which the machine entered the entire operation for three additional months. Once the new head of the CFL1 pump has arrived, it is verified that the base of the pump has also lost strength; the change of the base is planned. The machine is kept operational by hyper-pressurizing the system, and with hyper-pressurizing, the reducing valve at the point of entry of water from the ring; the machine operates with a maximum of 22 liters of replacement, this maneuver gave enough time to import the base of the pump.

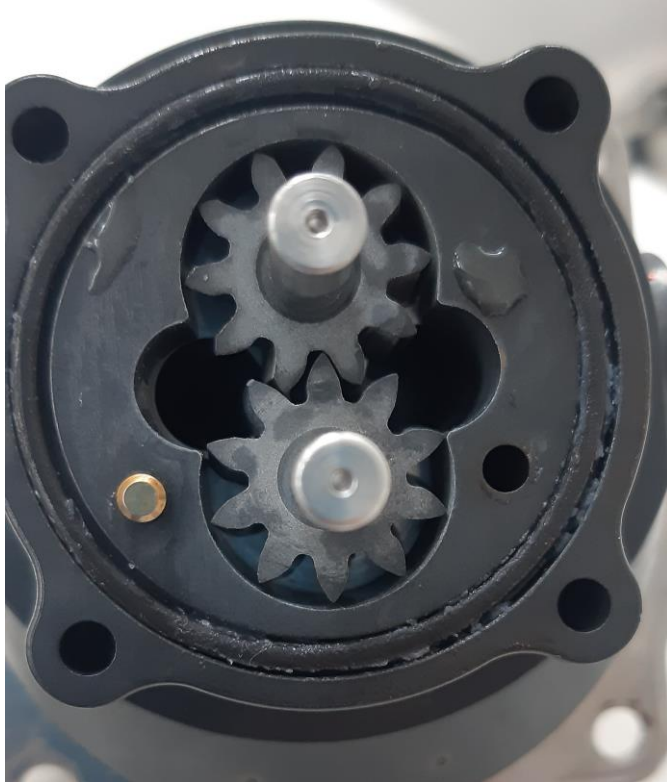
The operation of the hemodiafiltration system with high flow in the dialysate fluid (600 to 700 ml/min), with high substitution fluid replacement (>24 liters in postdilution mode or >38 liters in predilution mode), mainly causes the blades of the P2 pump to decrease their mass by friction (Figure 1) in a period of 24 to 30 months of continuous operation (3 shifts per day, six days per week). This wear of the blades of pump head P2 causes a drop in system pressure, causing a series of predictable, sequential errors (table 1).

Figure 1 Gear vanes of the dialysate fluid pressure motor. The friction area causes an undercut at the base of the upper blade, increasing the void space between the blades, which should be nonexistent.

The optimal option is to change the blades of the head. In principle, the system can compensate by recalibrating the dialysate fluid pressure and the water inlet pressure again; however, this causes a more significant workforce of the electromagnetic pumps P1 and P2, which continuously continue to lose power, and the problems continue to increase. A technical case of partial resolution is presented below, with the requirement to continue service of the hemodiafiltration monitor so as not to affect patient care. At the same time, imported spare parts arrive at the hemodialysis center.
